First Five-Year Review Report for the Bailey Waste Disposal Site Orange County, Texas

September 2000

**Bailey Waste Disposal Site
EPA ID# TXD980864649
Orange County, Texas**

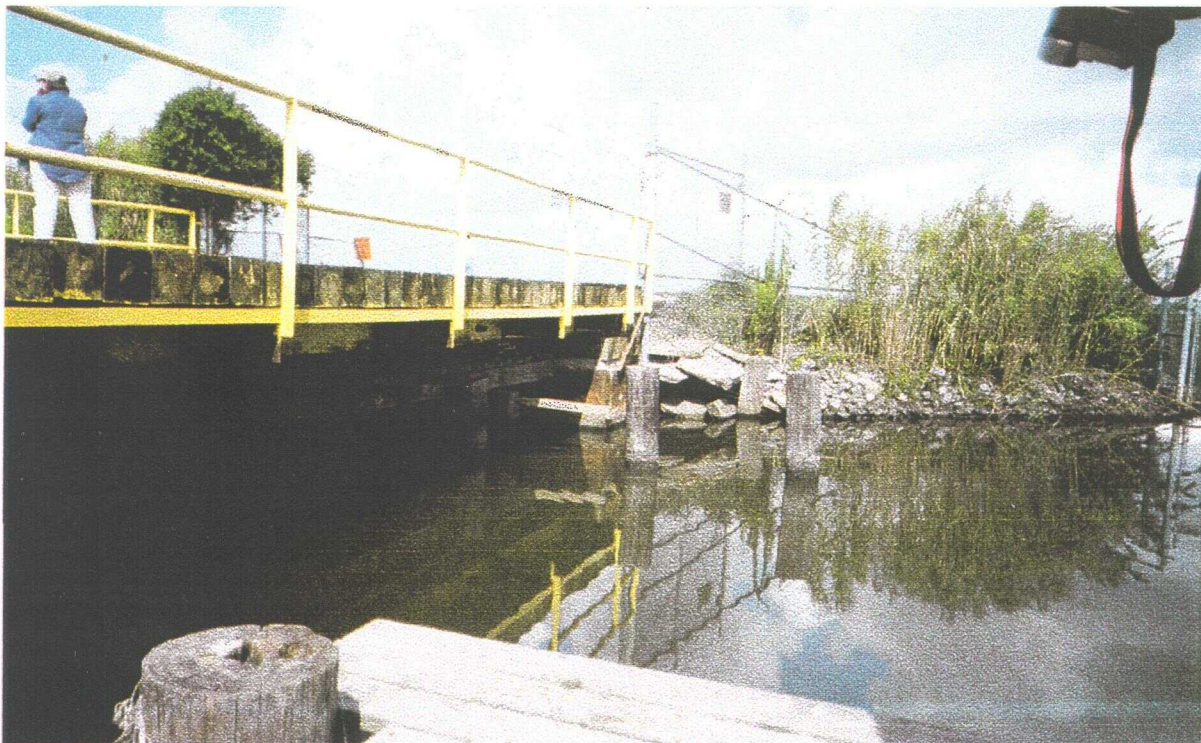
Photo No. 2 of 23	Date: 7/10/00	Time: 10:15	Taken by: Mark Taylor
View looking west at the BWDS site access bridge and of the secondary security gate.

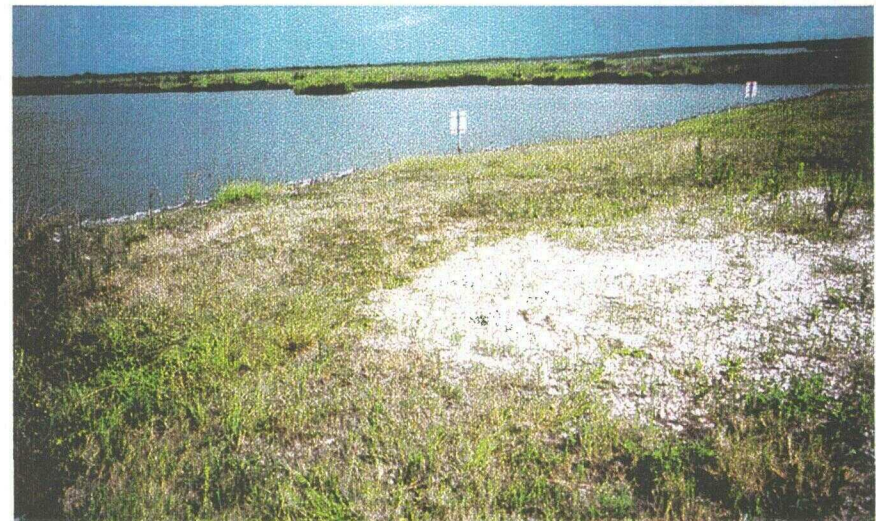
Photo No.	5 of 23	Date:	7/10/00	Time:	10:45	Taken by:	Mark Taylor
View of the west end of the North Dike Area looking northwest at the end of the access road.

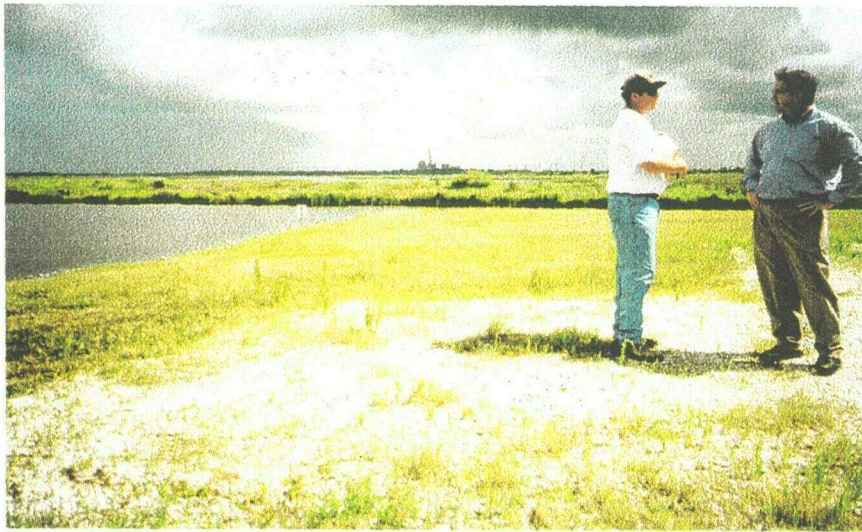
Photo No. 6 of 23	Date: 7/10/00	Time: 10:45	Taken by: Mark Taylor
View of the west end of the North Dike Area looking north at the end of the access road.

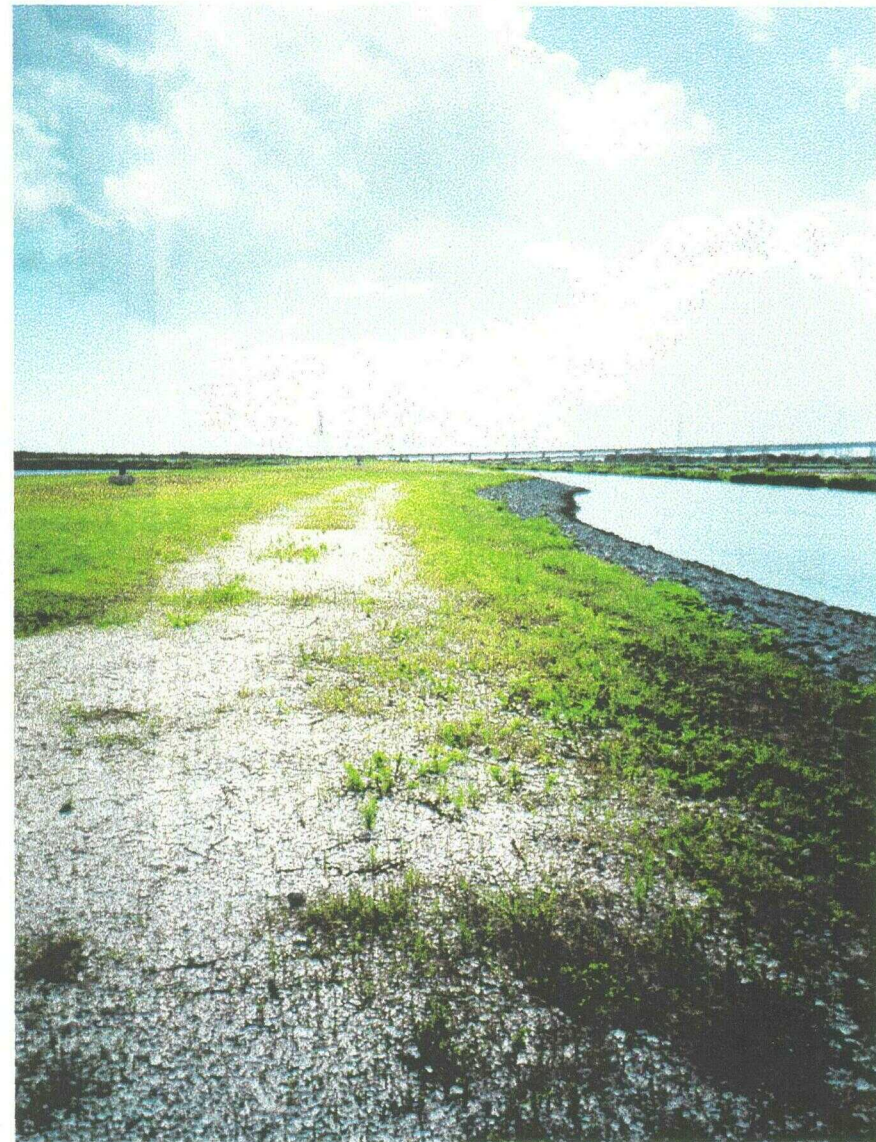
Photo No. 7 of 23	Date: 7/10/00	Time: 10:45	Taken by: Mark Taylor
View of the west end of the North Dike Area looking east towards the Rainbow Bridge.

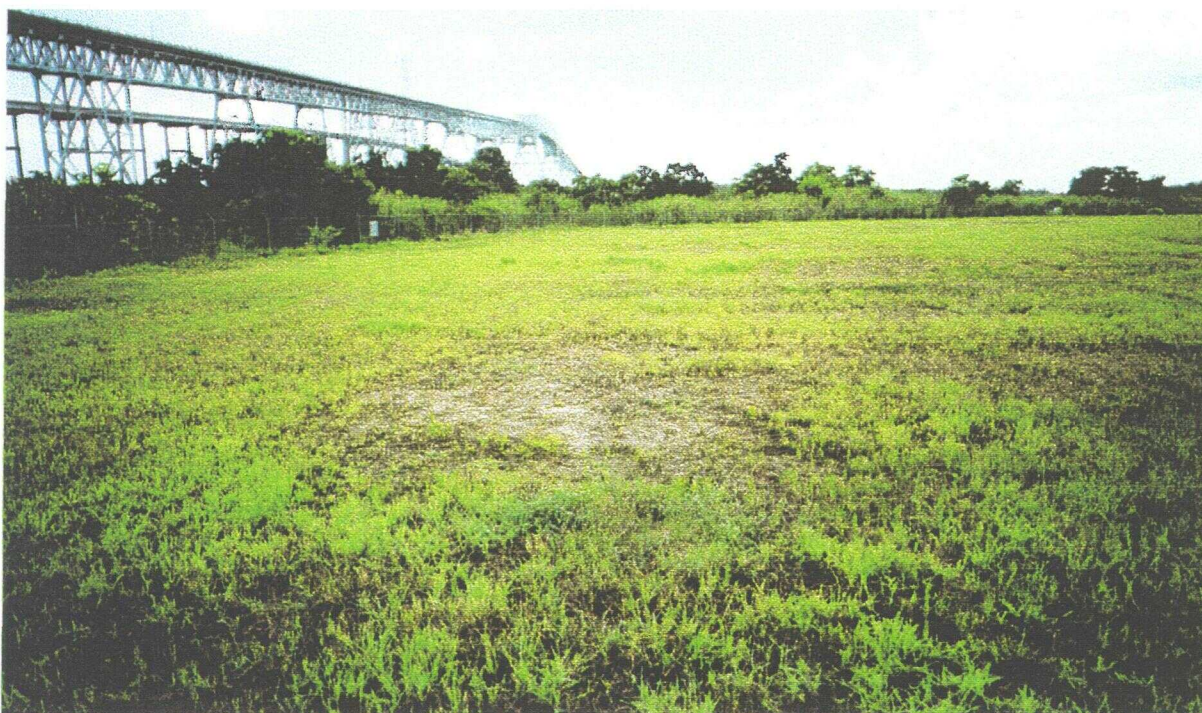
Photo No. 11 of 23	Date: 7/10/00	Time: 11:21	Taken by: Mark Taylor
View looking south at the southeast corner of the East Dike Area. Rainbow Bridge to the left.

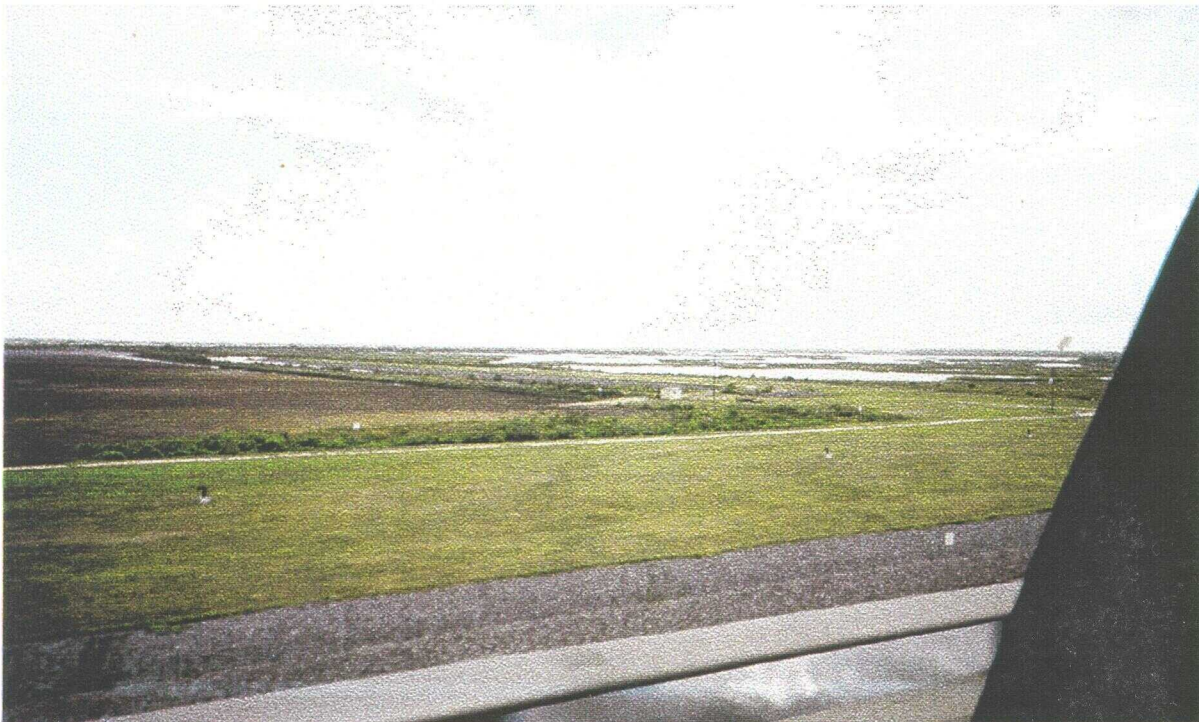
Photo No. 14 of 23	Date: 7/10/00	Time: 12:00	Taken by: Mark Taylor
View from the Rainbow Bridge looking west at the East Dike Area.

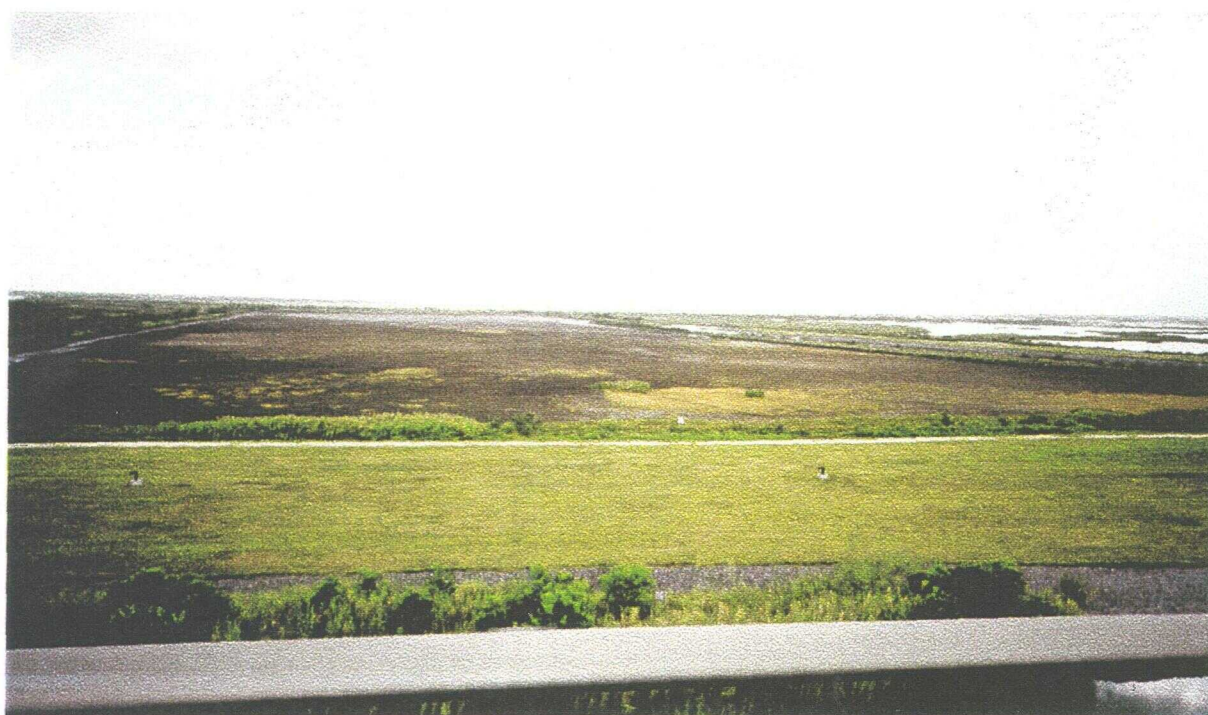
Photo No. 15 of 23	Date: 7/10/00	Time: 12:00	Taken by: Mark Taylor
View from the Rainbow Bridge looking west at the East Dike Area and dry pond.

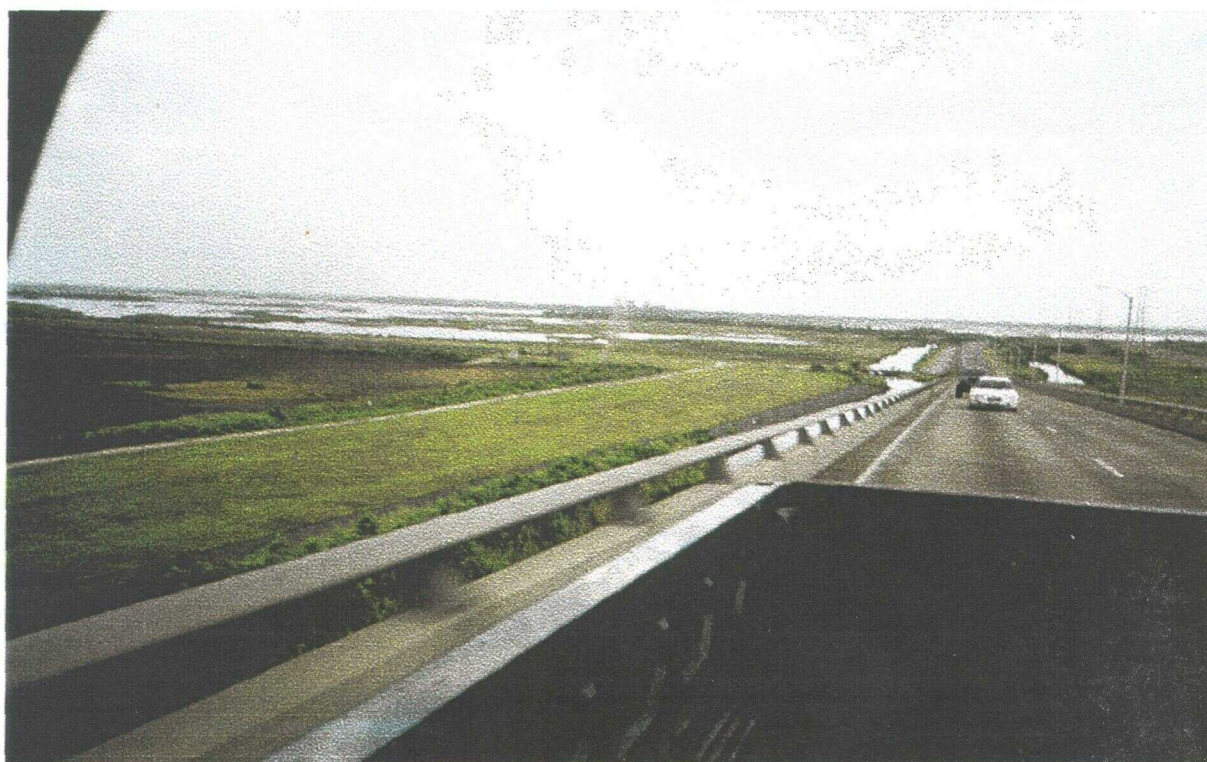
Photo No. 16 of 23	Date: 7/10/00	Time: 12:00	Taken by: Mark Taylor
View from the Rainbow Bridge looking north.

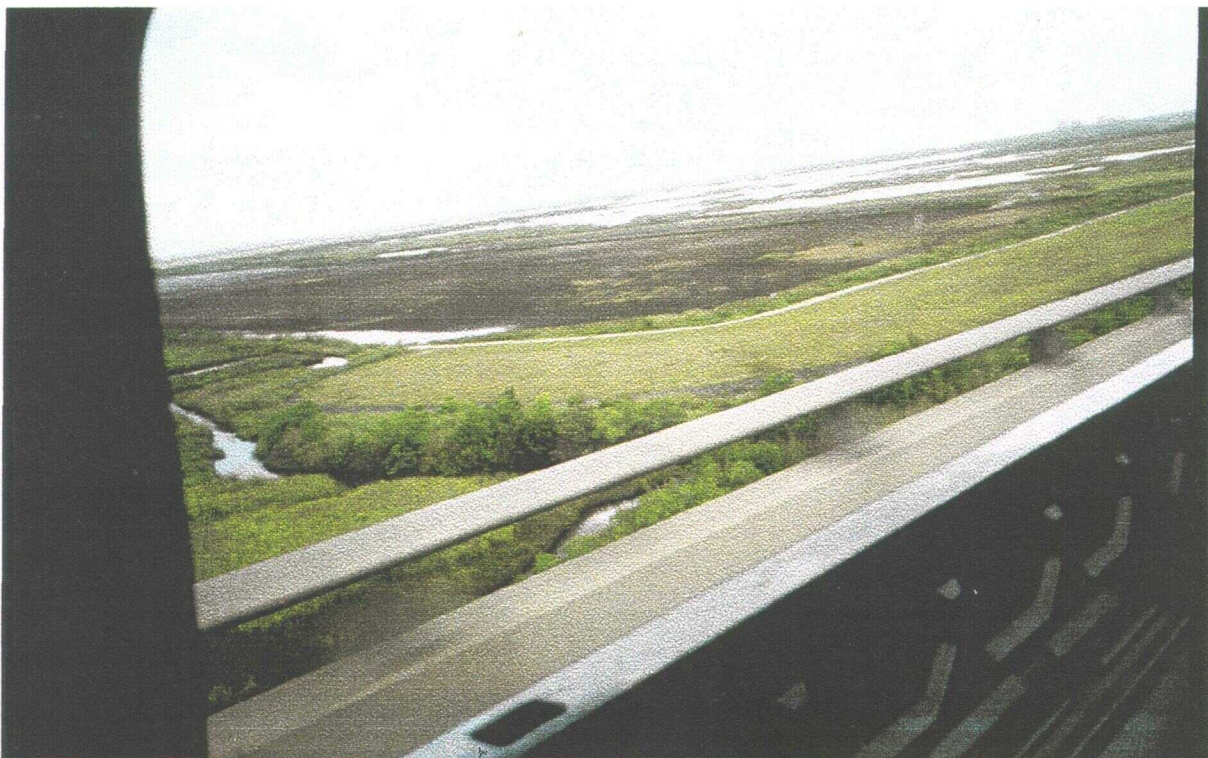
Photo No. 17 of 23	Date: 7/10/00	Time: 12:00	Taken by: Mark Taylor
View from the Rainbow Bridge looking northwest at the access road adjacent to the property.

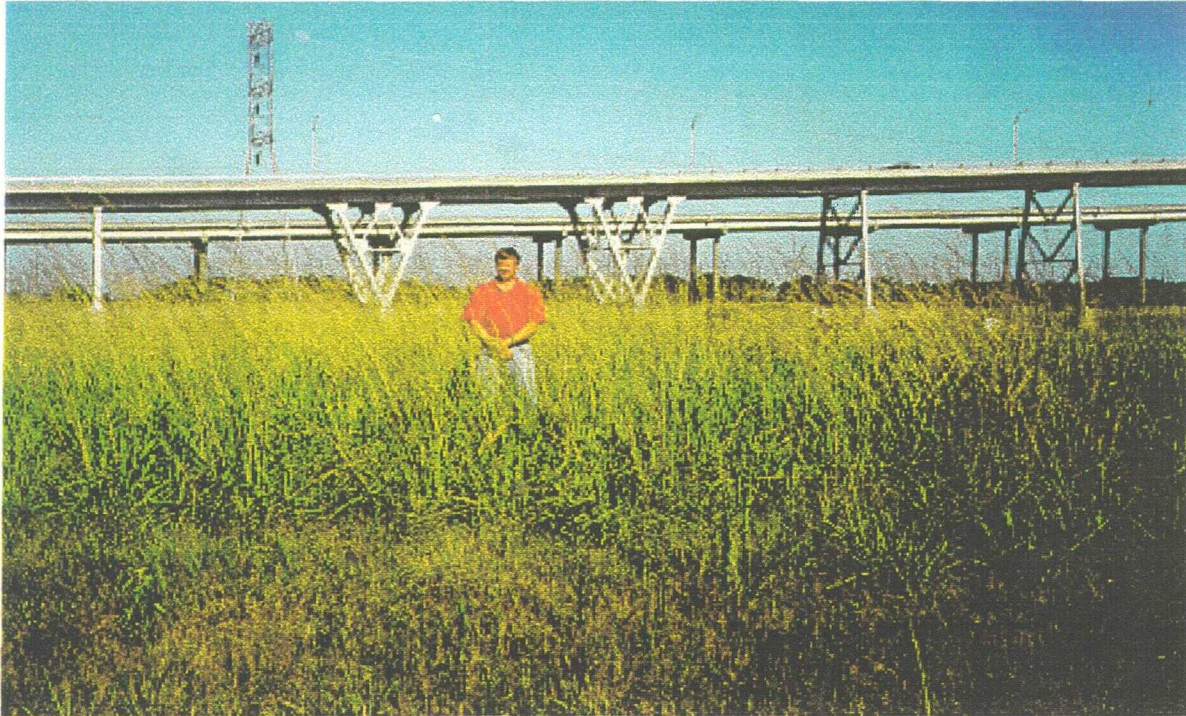
Certain damage to the cap could have occurred had the trespassers breached the site after heavy rains when the topsoil on the cap was most susceptible to impact damage. It should be noted that Mr. Townsend has notified the District Attorney's Office in Orange County, Texas, that he will prosecute anyone trespassing on his property. A copy of Mr. Townsend's letter to the District Attorney's Office in Orange County, Texas, has been included as Attachment 1 to this report. Photographs submitted by Mr. Townsend have been included in Appendix C as Exhibit 2 and are identified as pictures 18 through 24.

Photo No. 18 of 23	Date: Unknown	Time: Unknown	Taken by: Unknown
Photograph provided by Mr. Townsend.

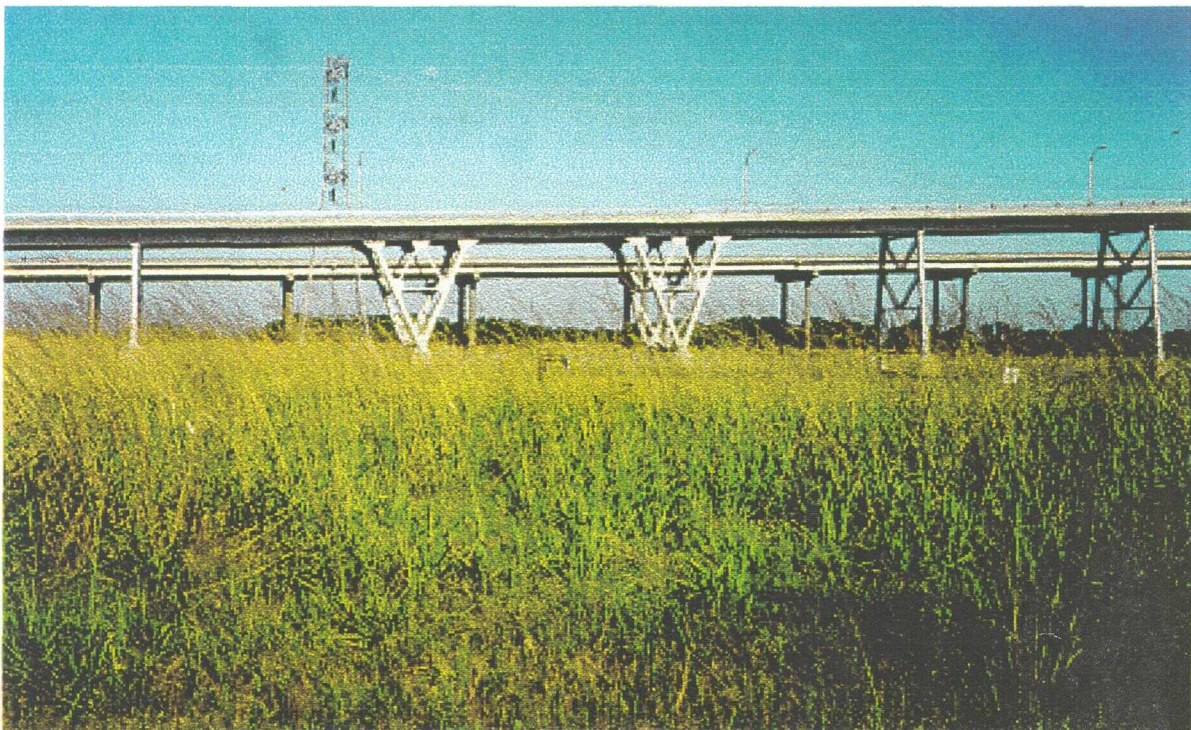
Photo No. 19 of 23	Date: Unknown	Time: Unknown	Taken by: Unknown
Photograph provided by Mr. Townsend.
